MERRIMACK RIVER BASIN
WESTMINSTER , MASSACHUSETTS

WESTMINSTER RESERVOIR DAM
MA 00639

**PHASE I INSPECTION REPORT
NATIONAL DAM INSPECTION PROGRAM**

JUNE 1980

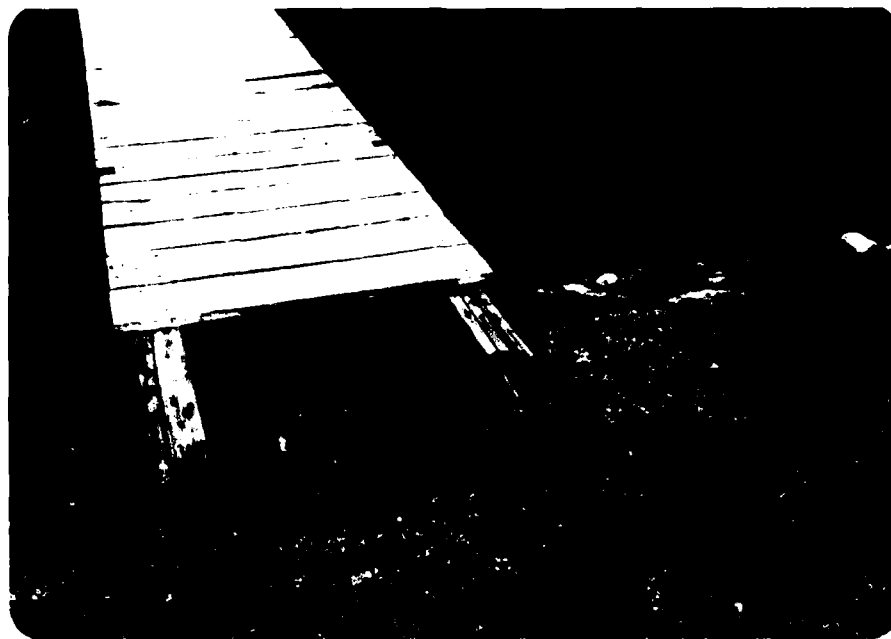
NO. 5 VIEW OF ACCESS BRIDGE & EROSION OF SLOPE

Moderate erosion was noted on the upstream slope of the dam adjacent to the gatehouse footbridge. (See Photo No. 5).

A few pieces of riprap have been dislodged from the upstream face of the embankment but it is generally in good condition. Several planks are missing from the gatehouse access bridge (see Photo No. 3 and No. 5).

- a. Operating and Maintenance Procedures. It is recommended that the Owner accomplish the following:
 - (1) To prevent continued erosion, fill in and re-seed eroded areas on the upstream face of the earth embankment portions of the dam.

- (4) Place earthfill and re-seed eroded areas on the upstream slope.
 - (5) Remove all debris and loose stone in the floor of the spillway discharge channel.
